NLD22 IP RATE TESTING

PICTURE	STATEMENT

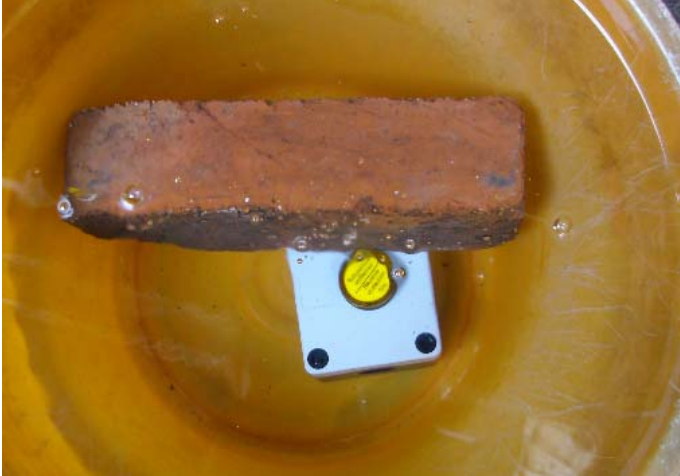
<p>Pic. 1. Put the NLD22 with IP66 control box into 40cm depth water for 1hour, and used a brick to steady, please refer to the left picture. The bubbles came from the gap of the brick.</p>

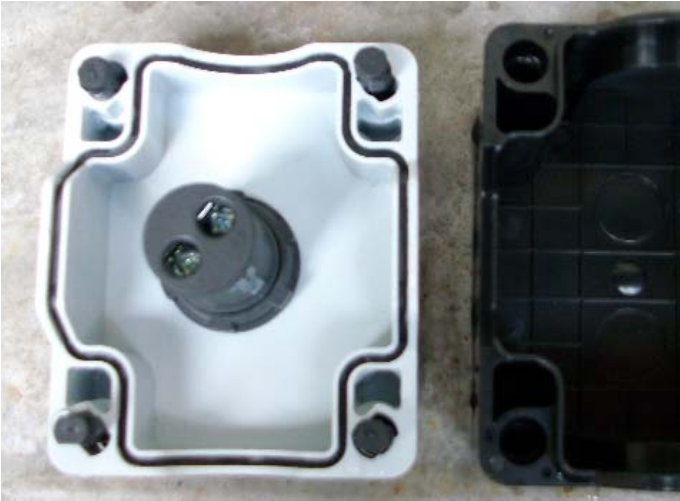
<p>Pic. 2. After an hour, we opened the control box and checked inside and NLD22, it didn't get wet at all. According to the condition of IPX7, when a devise is put into water for a half hour, then there is no leaking, it means our NLD22 & control box can reach IP66.</p>
